A Case Study of Mechanically Stabilized Earth (MSE) Retaining Wall Failure in the State of Tennessee; Recommendations for Future Design and Constructions

Hossein Alimohammadi^{id a,*}, Ashfaq A. Memon^{id a}

Terracon Consultants, Inc., Nashville, TN, USA 37217

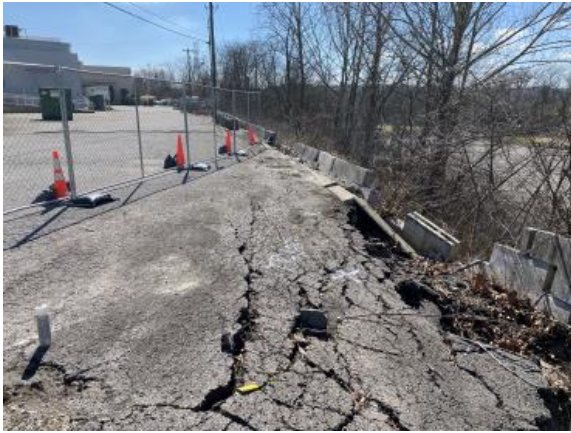
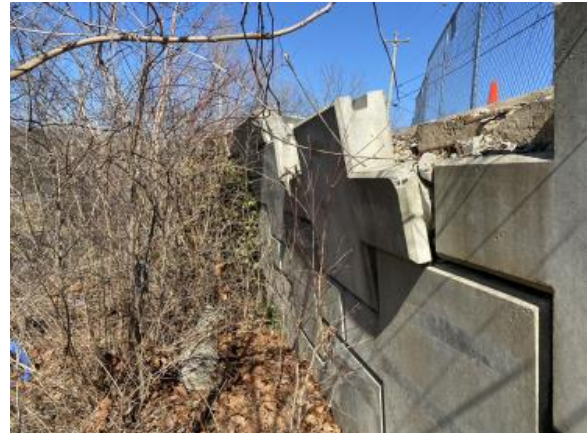
Figures 2a and 2b) The current state of the failed retaining wall

The retaining wall at the site has experienced partial failure along a section of its length, resulting in a loss of retained materials and consolidation of adjacent pavements. This mechanically stabilized earth (MSE) retaining wall was constructed using precast concrete panels interlocked with an anchorage system comprising concrete stretchers in the upper part of the wall and tandem epoxy-coated rebars with concrete deadman anchors in the lower portions. The approximate exposed height of the wall is estimated to be up to 10 feet tall. The wall was constructed to support new fill associated with the original grading of the existing development. However, a large portion of the wall has either failed or had its stability compromised. In some locations, the wall has completely collapsed, with the obvious failure of the wall anchorage system at its connection to the precast concrete facing panels. Figures 2a and 2b illustrate the current state of the failed retaining wall.

The assessment of the retaining wall failure revealed additional concerns beyond just wall movement. Both vertical settlement and lateral movement of the asphalt pavement and concrete curbs were observed over the reinforced backfill zone of the retaining wall. Our investigation suggests that the accumulation of surface water runoff from the parking lot, illustrated in figure 2a, has been directed towards the wall over time, instead of flowing into the designated site stormwater drainage system. The failure of the retaining wall seems to have occurred due to a connection failure at the facing panels, where the anchorage system pulled out of or sheared off the panels as illustrated in figure 2b. This failure may have been caused by backfill settlement and the added hydrostatic pressure imposed on the wall from the migration of surface water runoff into the backfill. Our examination also revealed anchor system failures both at the wall panel connection locations as well as within the concrete deadmen anchors, where rebars appeared to have pulled out from the concrete anchor block.

The intrusion of water into the soil rock mixture has resulted in the loss of strength in the backfill material, which has settled over time. It is noteworthy that most MSE wall systems of this type are designed using a free-draining granular backfill material. However, at several locations, the wall backfills contained significant amounts of clay that hindered the drainage of water entering the reinforced zone. As a consequence, lateral earth pressures acting on the wall system may increase, not only due to the added weight of the backfill material but also due to the likelihood of hydrostatic pressures imposed on the wall. Additionally, we observed the absence of any drainage system in the retaining wall such as weep

In this case study, the retaining wall on the north side has failed and requires complete removal and reconstruction to support the pavement and backfill. Various retaining wall systems are available for construction, a gravity wall concept was recommended for this site, such as Redi-Rock or gabion basket wall systems, or an MSE retaining wall system over traditional cast-in-place concrete retaining walls, soldier pile or secant pile walls for their cost-effectiveness. To ensure suitable bearing

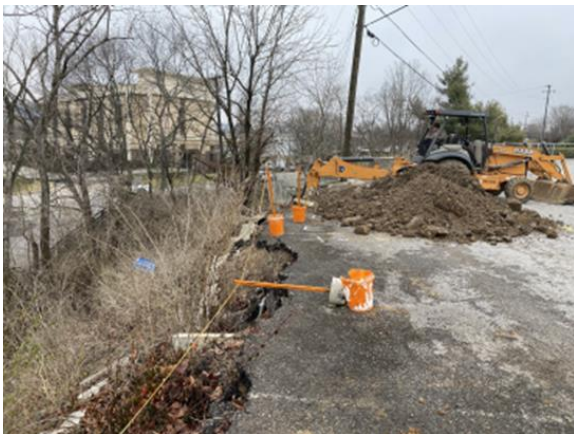
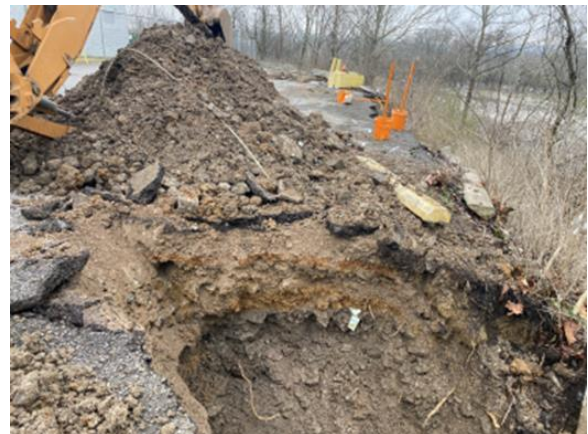
Figures 4a and 4b) Excavated test pits and subsurface conditions found in the backfill of the retaining wall

each excavated to a depth of 10 ft or until refusal, located in the backfill zone of the retaining wall. The subsurface exploration plan is presented in Figure 3, while Figure 4 a and b illustrate the excavated test pits and subsurface conditions found in the backfill of the retaining wall.

The investigation conducted in the backfill of the retaining wall revealed the presence of fill material up to a depth of 22 feet. The composition of the fill was highly variable, ranging from predominantly rock fill (with a majority of rock size <6") containing a small amount of clay to mostly clay with some limestone fragments. Additionally, occasional large-size rocks were observed during test pit excavations. Out of six borings, four were obstructed by large-size rocks before reaching the natural ground. At one of the boring locations, asphalt debris/pieces were encountered within the fill at a depth of approximately 13½ feet below the existing grade. The Standard Penetration Tests (SPT) conducted within the existing fill indicated erratic N-values, ranging as low as 4 to 5 bpf, indicating the presence of poorly compacted (compressible) material in some layers. Below the existing fill, the soil was found to consist of stiff to very stiff natural residual clay (lean clay) extending to a depth of about 30 feet without encountering bedrock.

an anchorage system consisting of concrete stretchers in the upper part of the wall and tandem epoxy-coated rebars with concrete deadmen anchors in the lower portions of the wall is used. The height of the exposed wall varied along its length and was observed to be as tall as 10 feet. However, our findings indicate that a significant portion of the wall has either failed or is compromised in terms of stability. At several points, we also observed a complete collapse of the wall, indicating an obvious failure of the wall anchorage system at its connection to the precast concrete facing panels.
